**BURBAGE CONSERVATION AREA
MANAGEMENT PLAN - CONSULTATION DRAFT**

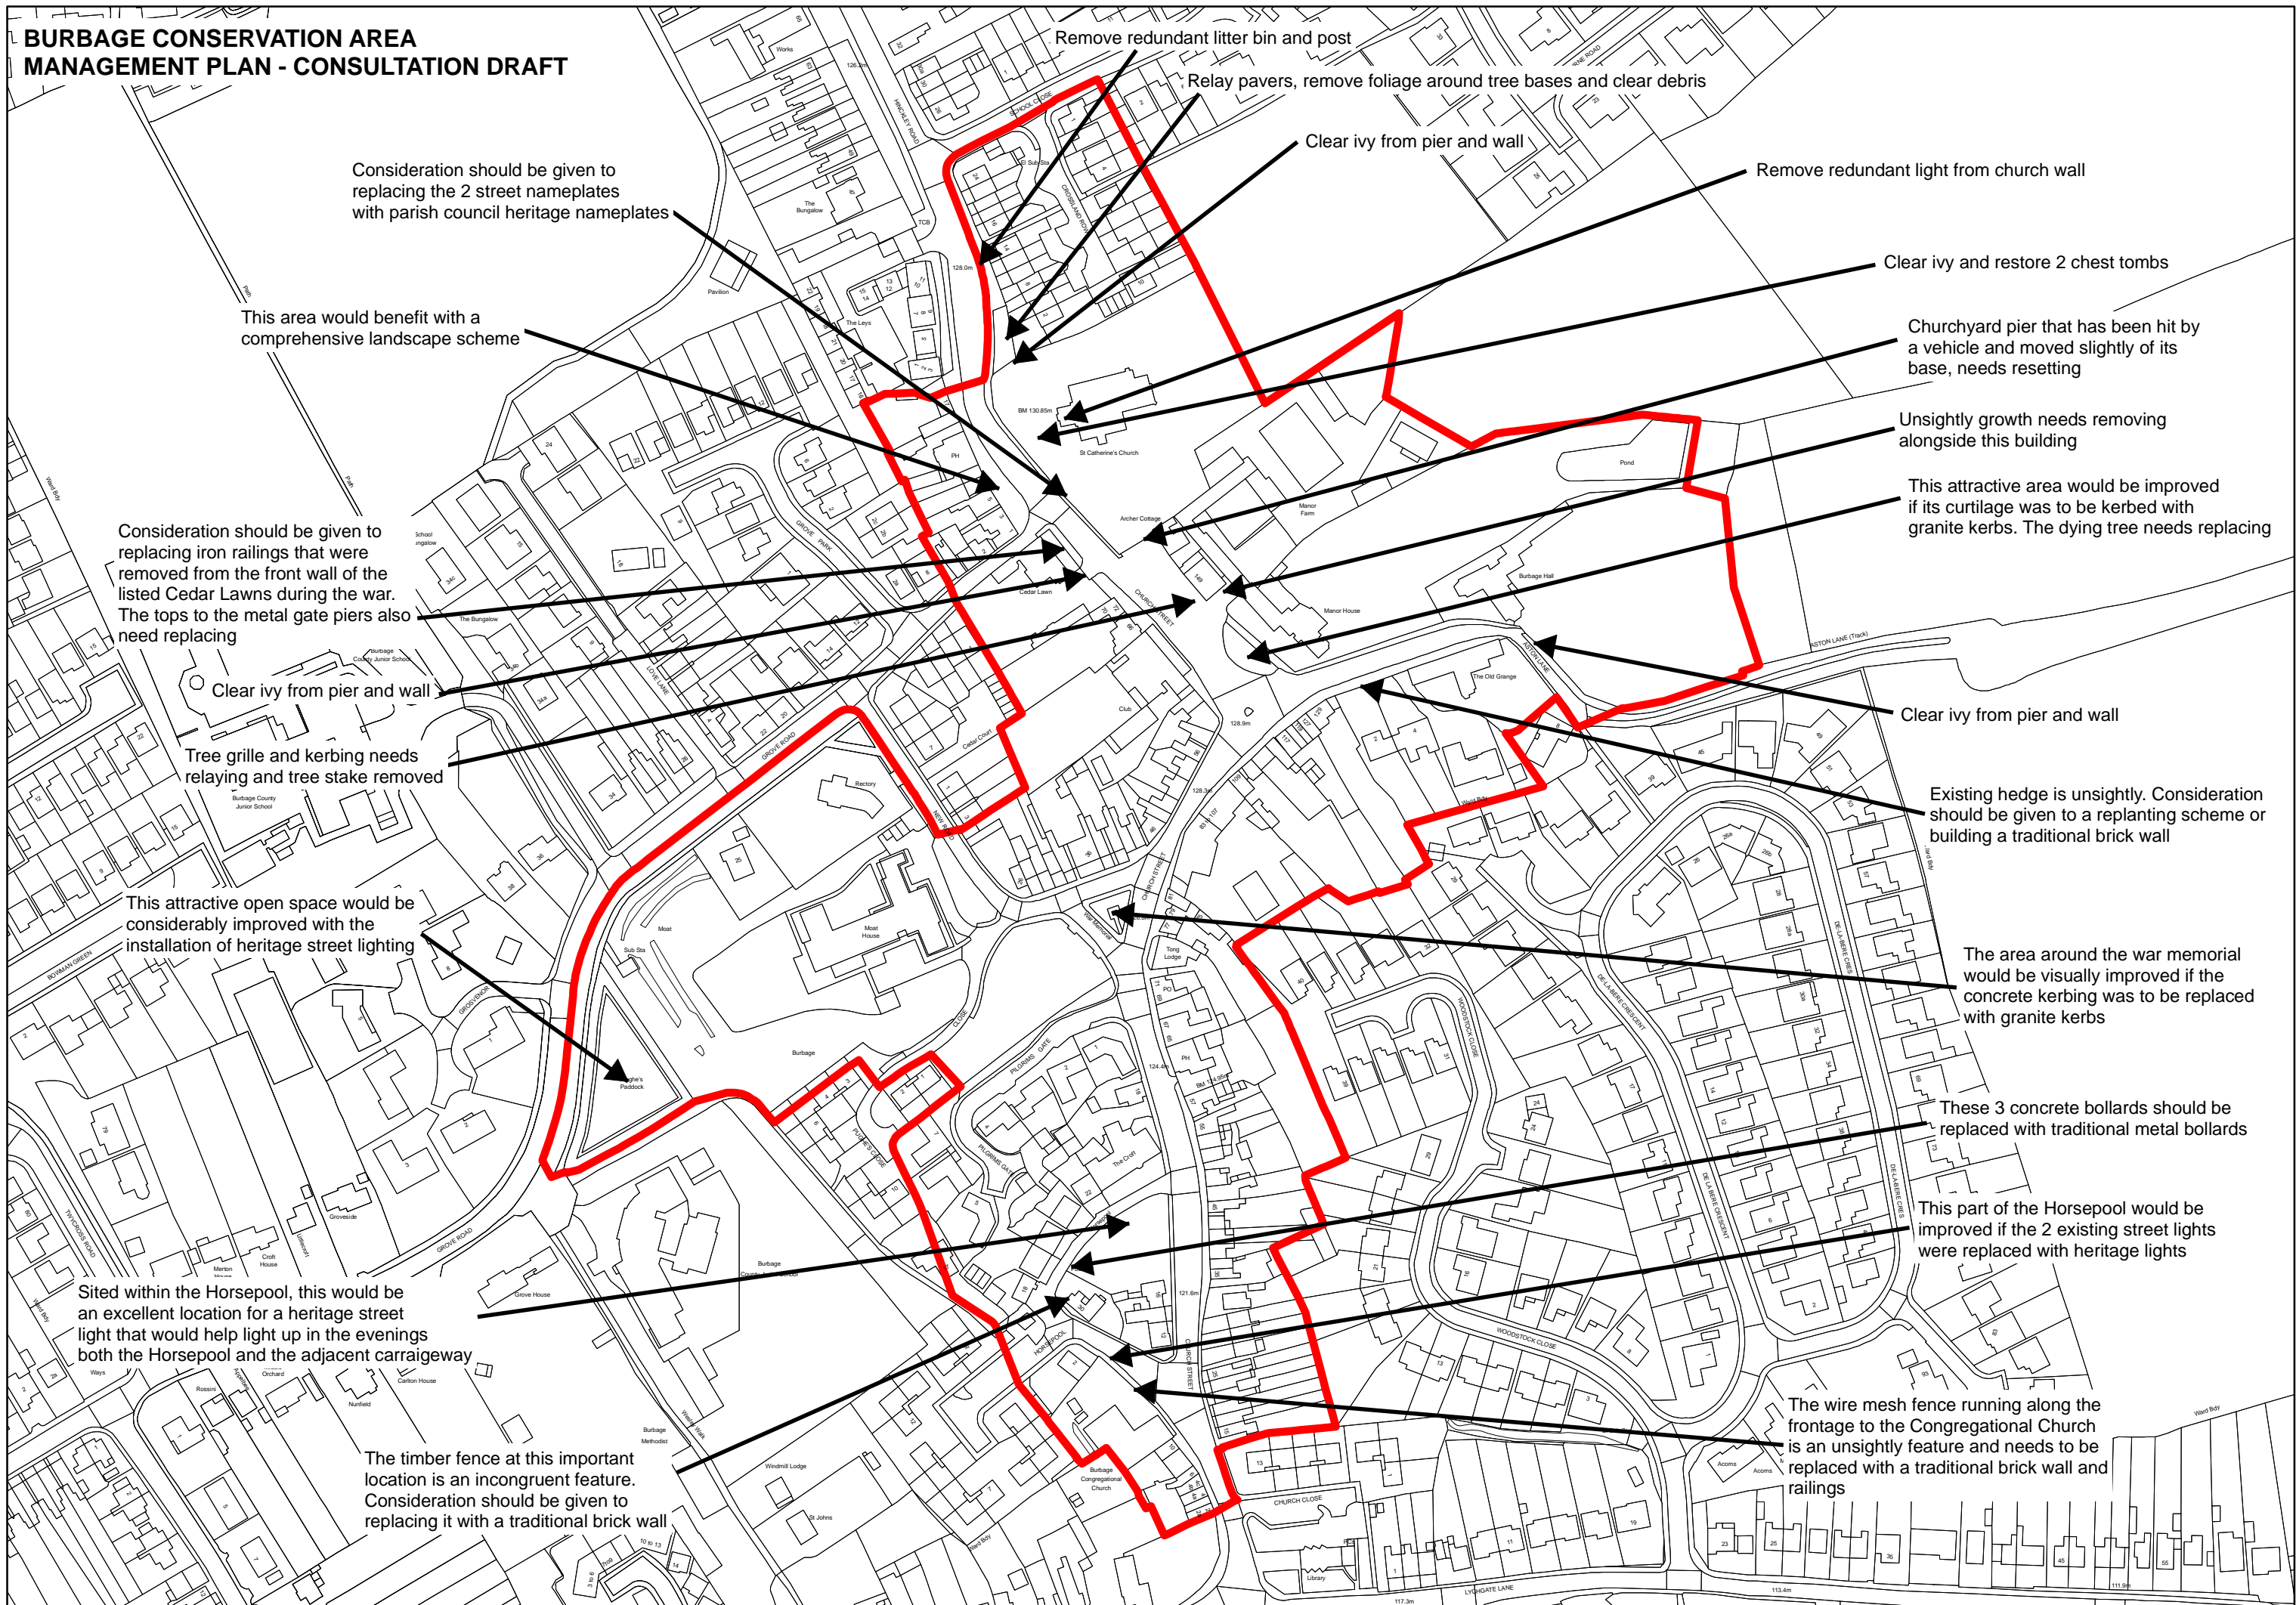
Consideration should be given to replacing the 2 street nameplates with parish council heritage nameplates

This area would benefit with a comprehensive landscape scheme

Consideration should be given to replacing iron railings that were removed from the front wall of the listed Cedar Lawns during the war. The tops to the metal gate piers also need replacing

Clear ivy from pier and wall

Tree grille and kerbing needs relaying and tree stake removed

This attractive open space would be considerably improved with the installation of heritage street lighting

Sited within the Horsepool, this would be an excellent location for a heritage street light that would help light up in the evenings both the Horsepool and the adjacent carriage way

The timber fence at this important location is an incongruent feature. Consideration should be given to replacing it with a traditional brick wall

Remove redundant litter bin and post

Relay pavers, remove foliage around tree bases and clear debris

Remove redundant light from church wall

Clear ivy and restore 2 chest tombs

Churchyard pier that has been hit by a vehicle and moved slightly of its base, needs resetting

Unightly growth needs removing alongside this building

This attractive area would be improved if its curtilage was to be kerbed with granite kerbs. The dying tree needs replacing

Existing hedge is unsightly. Consideration should be given to a replanting scheme or building a traditional brick wall

The area around the war memorial would be visually improved if the concrete kerbing was to be replaced with granite kerbs

These 3 concrete bollards should be replaced with traditional metal bollards

This part of the Horsepool would be improved if the 2 existing street lights were replaced with heritage lights

The wire mesh fence running along the frontage to the Congregational Church is an unsightly feature and needs to be replaced with a traditional brick wall and railings
